Galloway Inspection Services, Inc.

Client: Cecil Galloway

Inspected On: 06-28-2014

Inspection Type: Personal Home Inspection

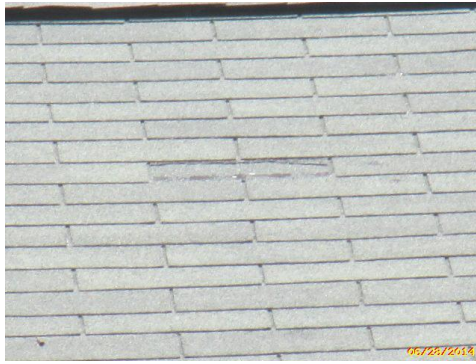
2. Missing Shingle Tab

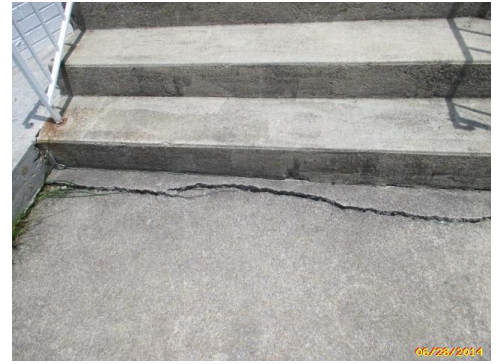
3. Crack At Front Steps

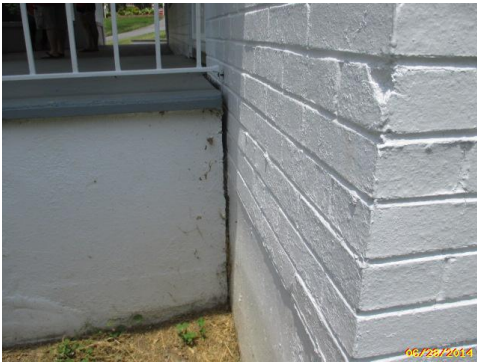
4. Gap At Porch

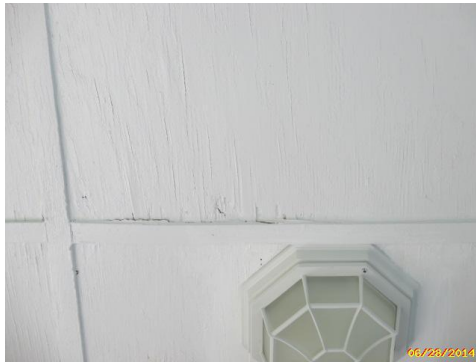
- The wood ceiling of the front porch has several small areas of deterioration from past leaks. There is no access to the attic area over this area to inspect. The damage is old and does not appear to be active. However, these areas should be monitored to ensure that there are no active leaks.

5. Deteriorated Porch Ceiling

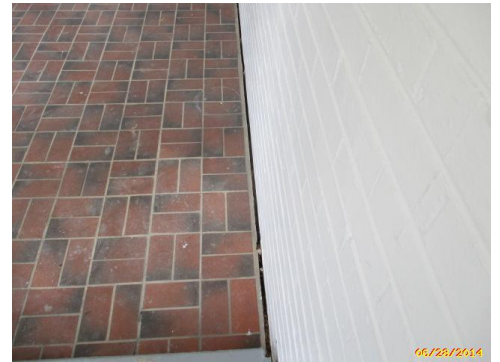
- The front porch and original front stoop have settled and pulled away from the house. This has caused a gap where the porch connects to the house. These gaps should be sealed. The porch roof is supported by a brick wall and brick columns.

6. Gap At Front Porch And House

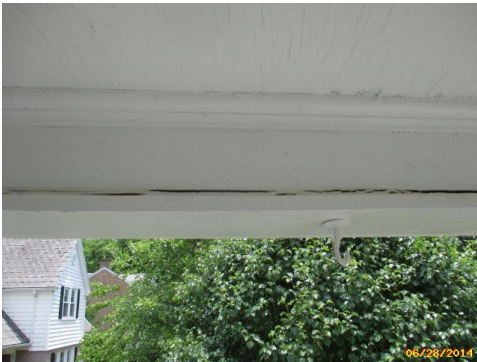
7. Gap In Porch Trim

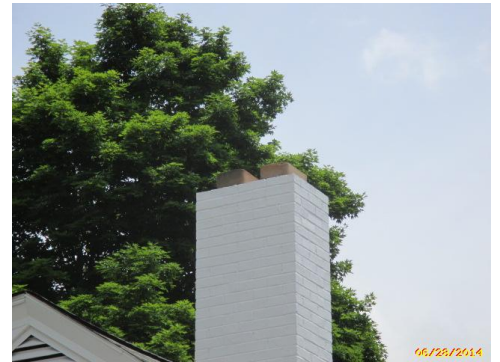
- The chimney does not have a cap. This could allow water and or birds to enter the flue. Caps should be installed to prevent the entry of water and birds.

9. No Caps On Chimney

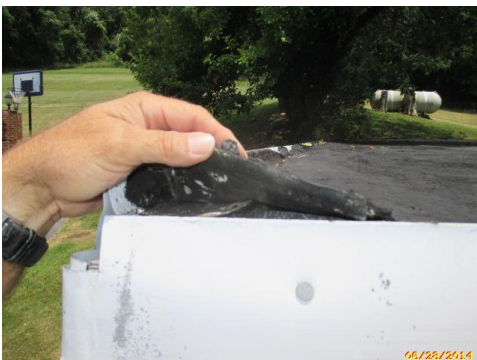
10. Loose Garage Roof Membrane

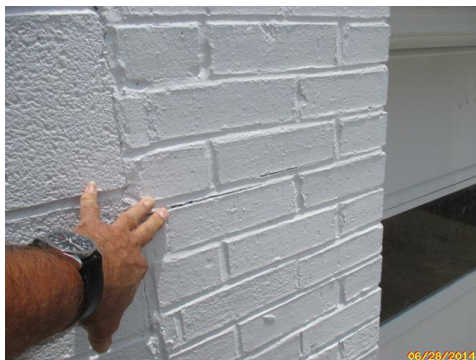
- There is a small settlement crack in the front brick wall of the garage. The crack should be sealed and monitored for any further widening. If the crack continues to widen, a licensed general contractor should be consulted to make recommendations for any needed repairs.

11. Crack In Garage Brick

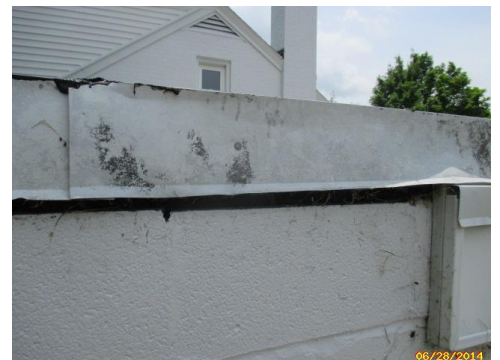
12. Gap At Left Garage Roof

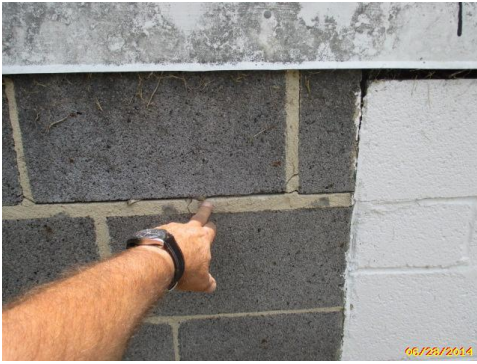
13. Crack In Garage Block

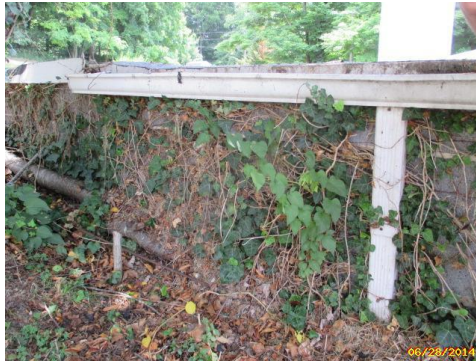
- There are vines growing along the left garage wall. These vines can be very destructive and should be removed.

14. Vines On Garage

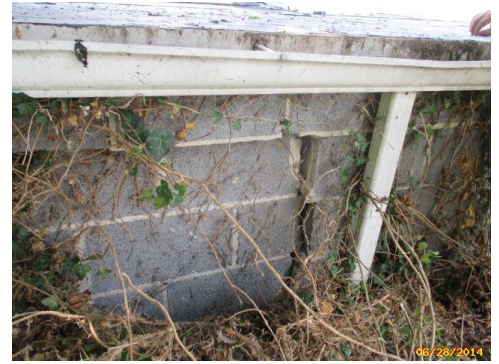
- The left exterior concrete block wall of the garage is collapsing. A new concrete concrete block wall and steel braces have been installed on the interior of this wall to prevent the original wall from failing. An engineering letter should be procured for the repairs made to the garage wall to ensure the repairs made will solve the issue. There is a settlement crack on the right side interior garage wall. The crack is small but should be sealed and monitored for any further widening. If the crack continues to widen, a licensed general contractor should be consulted to make recommendations for any needed repairs.

15. Garage Wall Collapsing

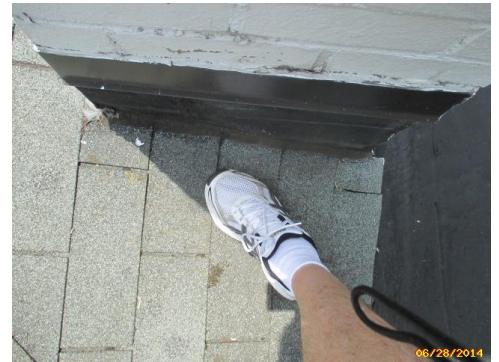
- There is a soft spot in the roof sheathing to the rear of the chimney. The damage is not visible and is more than likely from a past leak. The extent of the damage is not known and can be repaired when a new roof is installed.

18. Soft Spot In Sheathing At Chimney

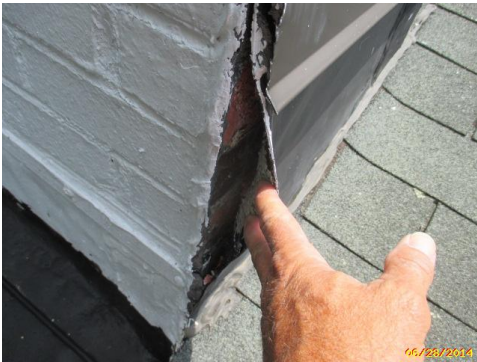
- The rubber membrane that seals the gap for the chimney is not sealed along the exterior edge. This could allow water to enter and cause damage to the roof. The membrane should be properly sealed. There is a loose portion of the garage roof membrane at the front left corner and the flashing. This could allow water to enter and cause damage. The membrane should be properly sealed.

19. Loose Chimney Flashing

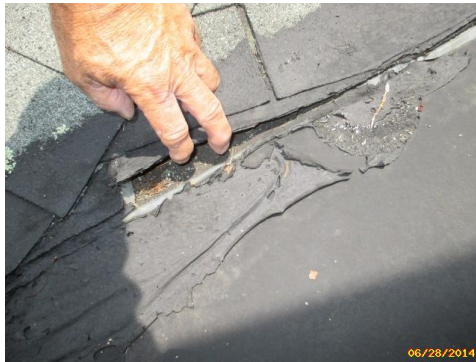
20. Gap In Rear Roof Membrane Flashing

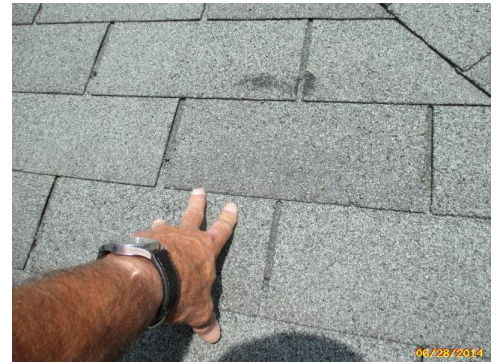
- The singles are old and show signs of wear with much granule lose and small areas of damage from hail and other means. There is a missing shingle tab at the front right roof section. There is an area of roof at the rear of the house between the main structure and rear den that is covered with a rubber membrane. There is a gap in the membrane where the shingles overlap which could allow water to enter and cause damage. The gap should be sealed and or redone to prevent water entry. The rubber membrane garage roof has areas of repair where tar was added to prevent or stop a previous leak. There are areas that show signs of water ponding which will degrade the roof over time. The garage roof is old and may need replacing in the near future. A roofing contractor should be contacted to evaluate the roof and any repairs or replacement that may be needed.

21. Worn Shingles

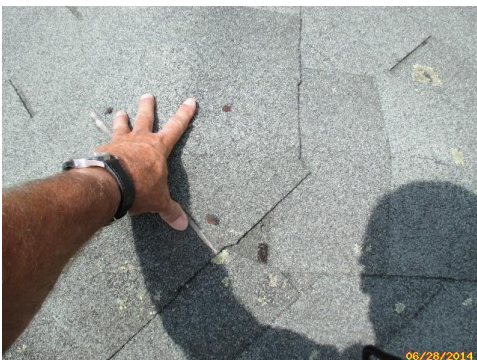
22. Exposed Nails On Roof

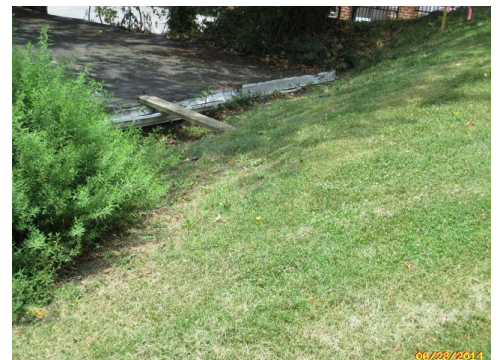
- There is a general slope from the rear of the lot to the front. The slope is rather steep and terminates at the rear of the garage and the house. There are no means present to divert any surface water that might run toward the house and contact the foundation. A control ditch or other structure should be installed to divert the water away from the foundation. A landscape contractor should be contacted to make recommendations for diverting the water flow.

24. Slope Toward Garage

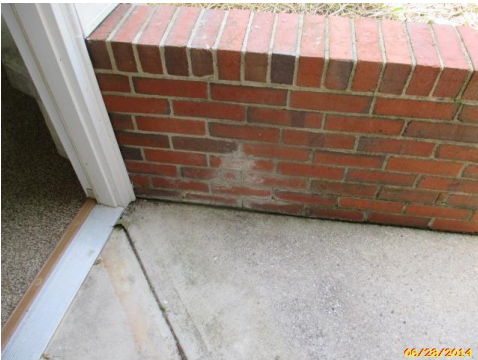
- There were no signs of water infiltration of the house foundation walls. The rear garage concrete block wall did have signs of moisture infiltration. Diverting the surface and possible sub surface water flow would help to reduce this source of moisture.

28. Sign Of Moisture At Retaining Wall

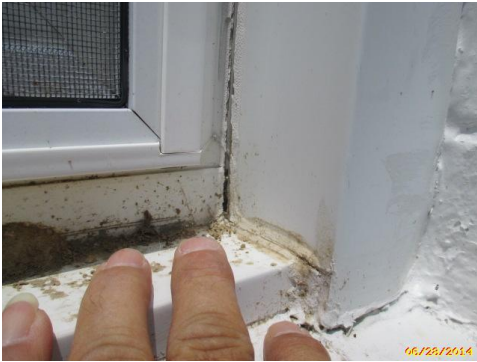
There are gaps in the aluminum window trim where the side trim meets the sill. This could allow water to enter and cause deterioration. These gaps should be sealed.

37. Gap At Window Trim

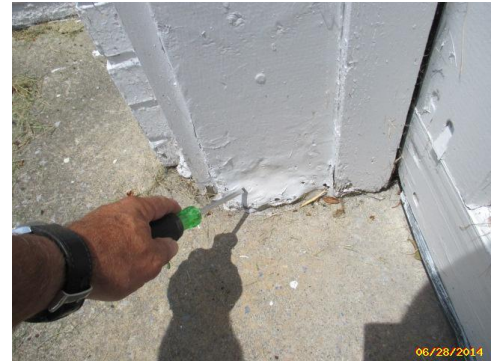
39. Past Deterioration At Garage Frame

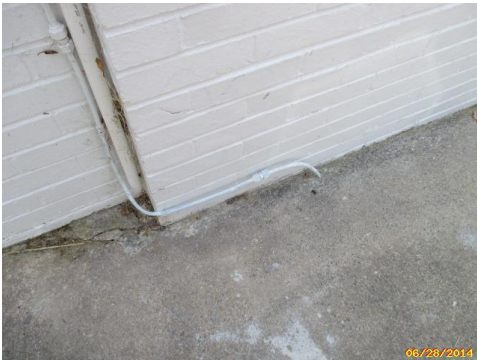
Supply Returns:	S	
Inside Fan Motor:	S	
Fireplace:	U	The propane lines feeding the gas logs in each fireplace are unprotected. The lines are run along the exterior of the brick wall and exposed to possible damage. The lines should have been installed in a protective cover. There are gas logs mounted in the fireplaces. These are older units and should be inspected by a supplier prior to any use. The gas lines for the logs was disconnected and the units were not tested. The fire place in the den has gaps between some of the fire brick liners.

40. Propane Line Unprotected

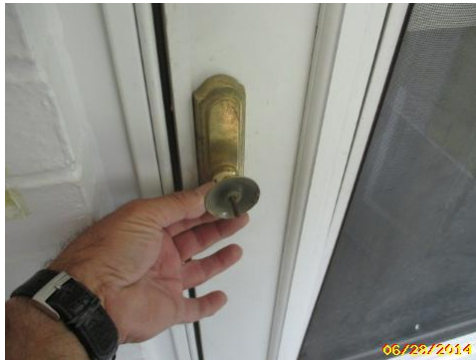
- The front storm door handle is broken and does not latch. The exterior knob is also broken. There is a gap between the wood frame holding the storm door in place and the brick wall. This gap should be sealed to prevent water from entering and causing damage.

41. Damaged Storm Door Handle

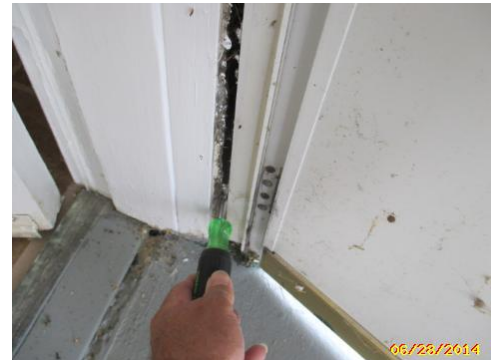
42. Gap At Storm Door And Front Door

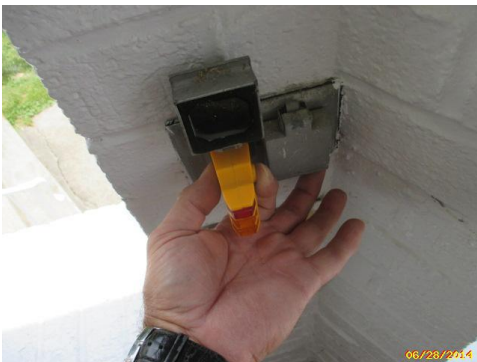
43. Porch Receptacle Not GFCI

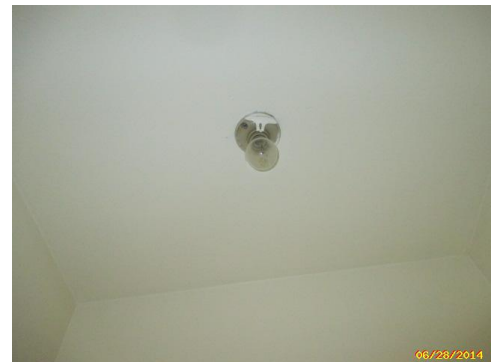
45. Coat Closet Light Not Working

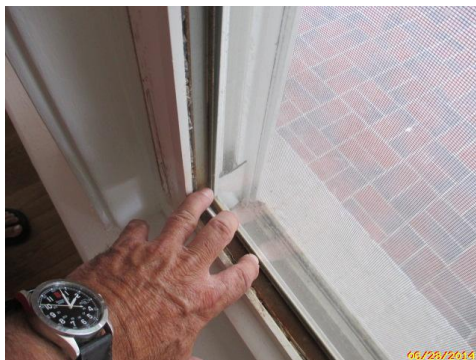
- The front right living room window is missing the interior pane of the double pane window. The window is also hard to open. All the other windows in the house are missing or have damaged latches which hold the window sashes in the frame. This will allow the windows to tilt inward when open. All of these window latches should be repaired or replaced to allow the windows to operate properly. The second floor right bedroom has a right window with a damaged spring which will not hold the window open. This is a hazard and the spring should be repaired. The window manufacturer should be contacted to have a technician repair the windows.

47. Missing Interior Glass Pane

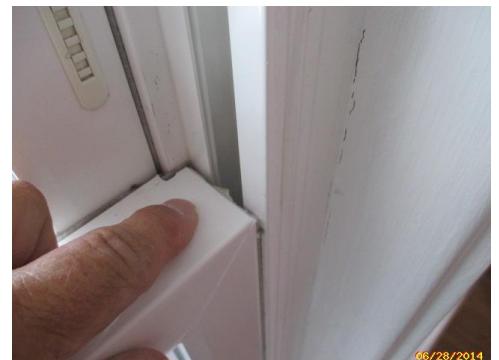
48. Window Latch Missing

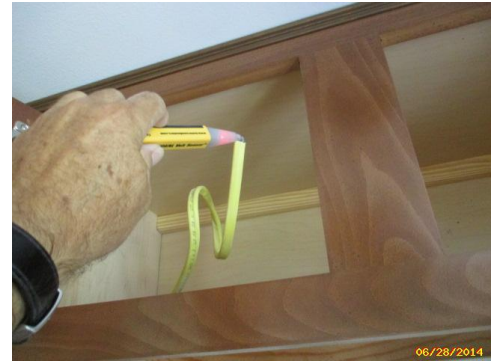
51. Active Wire Above Range

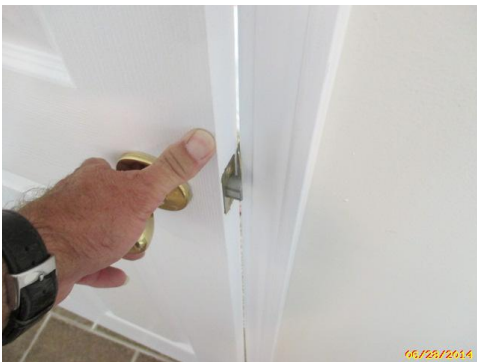
- The door to the bathroom off of the den and the laundry room were not properly installed and do not allow the doors to close. The latching side of the frame needs to be moved back to allow the door to close. Both doors to the second floor bathroom have non working latches. One door has a door knob that does not work the latch and the other has a latch that does not want to open. The master bathroom door sticks in the frame at the bottom portion of the door.

55. Bath Door Not Close

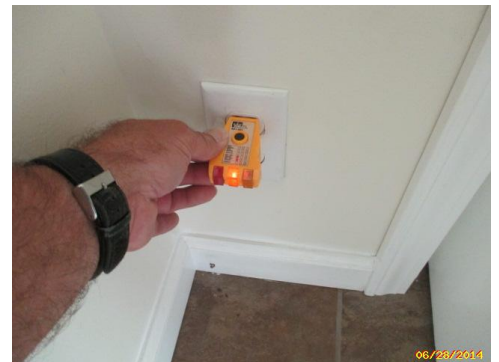
57. Ungrounded Receptacle Den

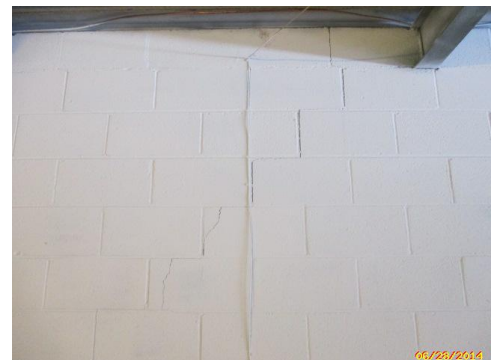
60. Crack In Garage Wall

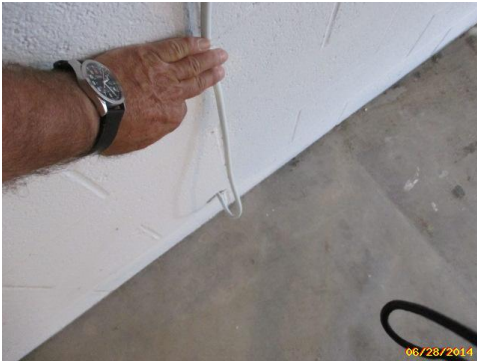
61. Unprotected Propane Line

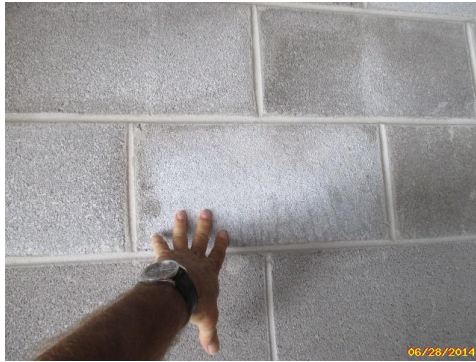
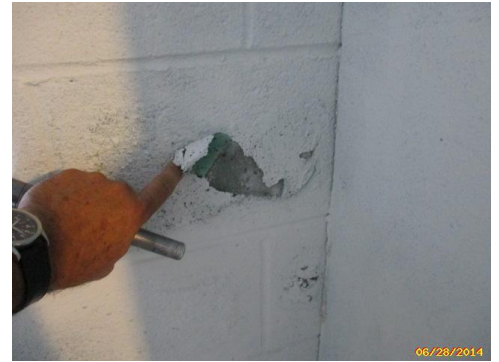
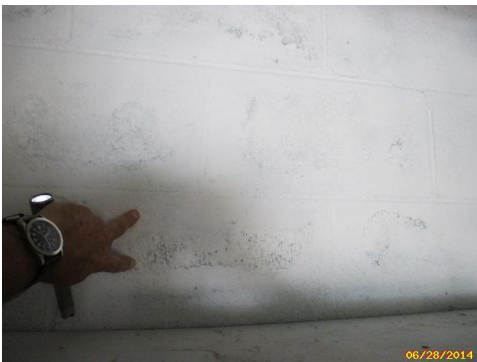
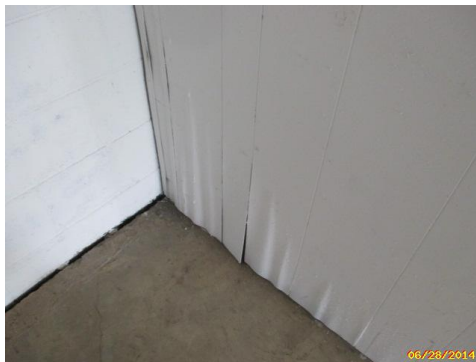
62. Sign Of Moisture

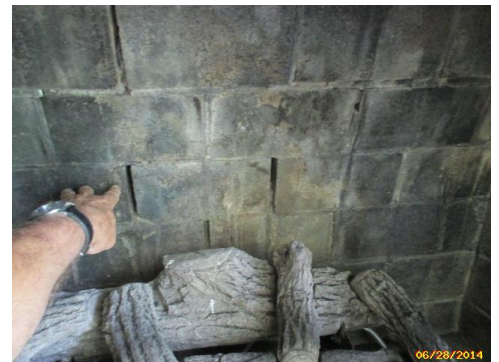
66. Gaps In Fire Brick

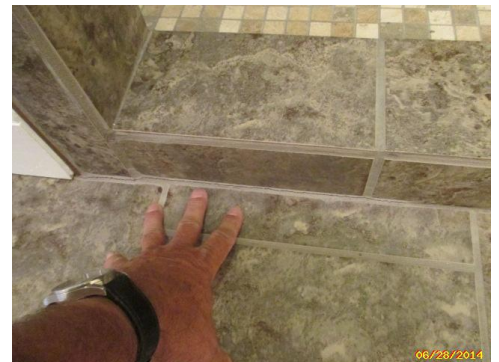
69. Small Gap At Shower Grout

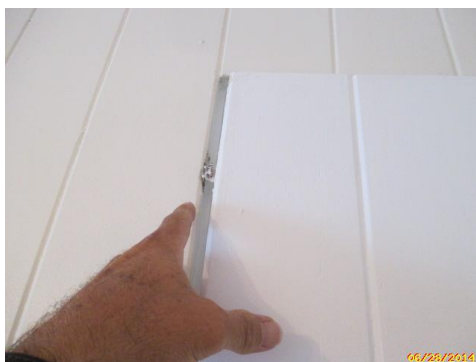
71. Broken Cabinet Hinge Bedroom

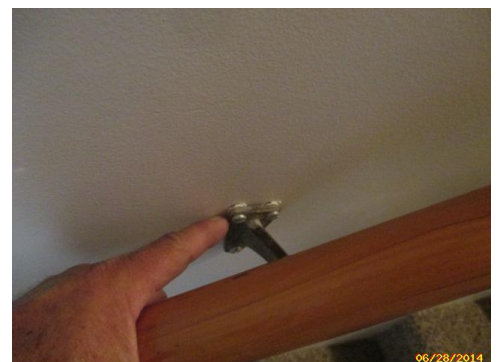
72. Loose Rail Connection

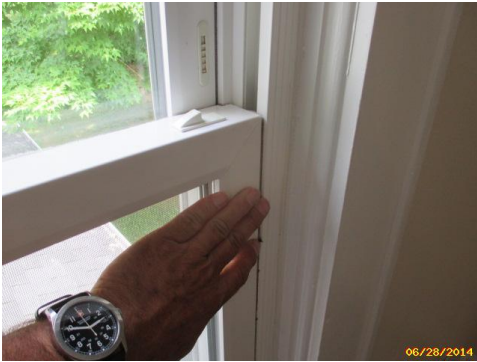
73. Spring Not Working Bedroom Window

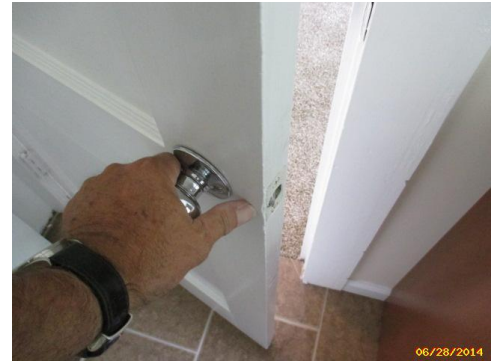
75. Bath Door Knob Not Working

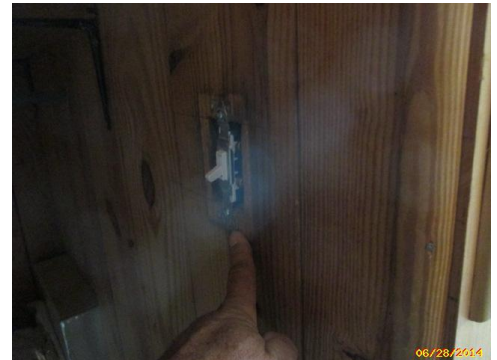
78. Missing Cover

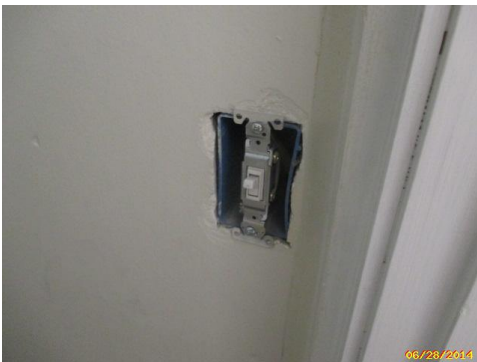
79. Missing Cover

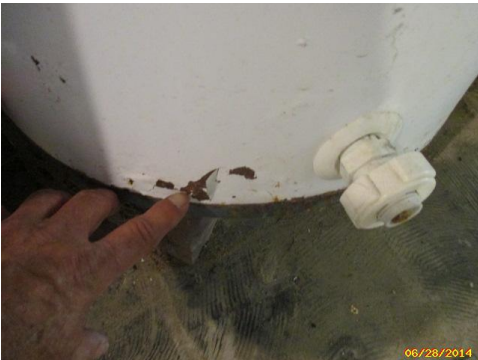
88. Rust On Older Tank

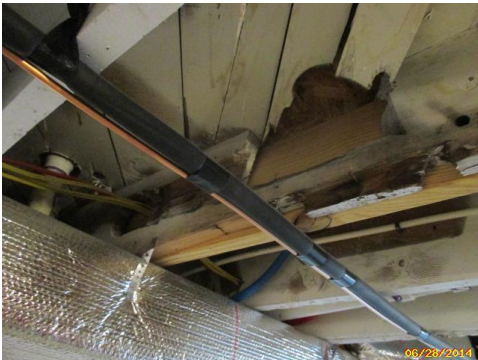
- A floor joist under the bathroom has been cut to install and or remove a drain pipe. Another partial joist was installed to add strength to the cut joist. There is also some insect damage to several other joists at the middle of the basement. The damage is restricted to the first inch or less of the joists. A licensed general contractor should be consulted to make recommendations for any needed repairs.

89. Cut Floor Joist

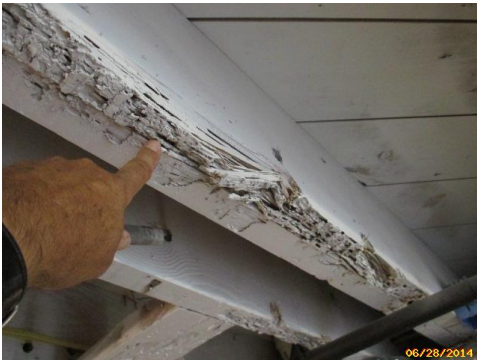
90. Sign Of Insect Damage

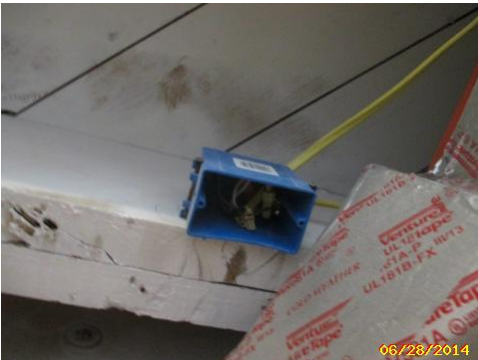
91. Open Junction Box

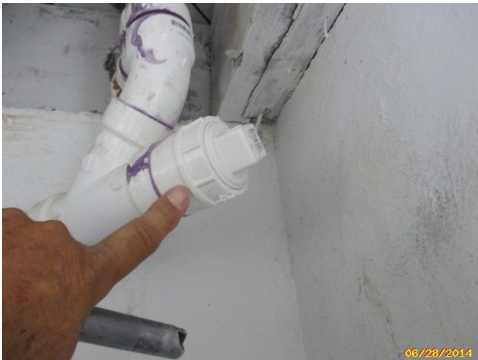
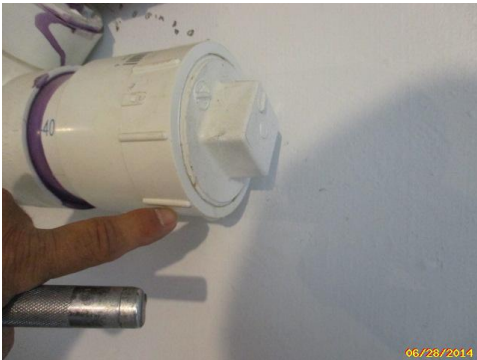
- There are slight leaks at two cleanouts at the main drain and at a secondary drain. There was no tape used to seal the threads on the access plugs causing a slight drip. A licensed plumbing contractor should be contacted to make recommendations for any needed repairs.

92. Leak At Clean Out

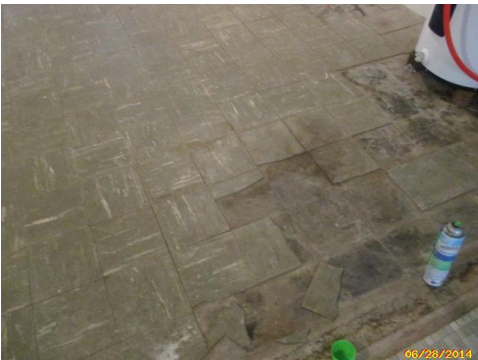
- There are settlement cracks in the concrete and asphalt walk and driveway. Sealing these cracks will help prevent water entry and further damage.
- The basement concrete floor is covered with floor tiles which may contain asbestos. Given the age of the house this is very possible. The tile should be tested to determine if any asbestos containing substance is present and how best to mitigate the issue. An environmental contractor should be contacted to make recommendations for testing and mitigation.

94. Possible Asbestos Tiles

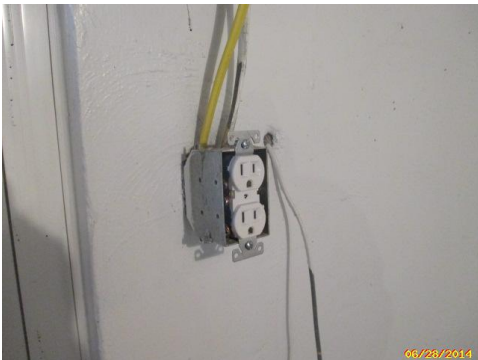
95. Missing Cover

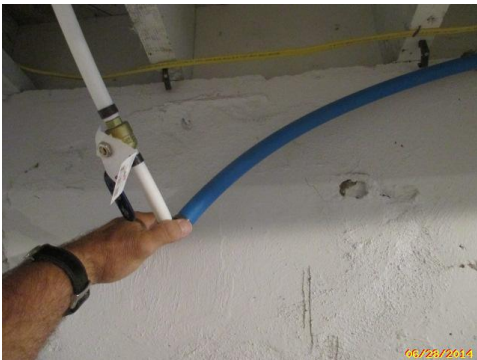
- One of the PEX water lines has come loose from its securing pins and is hanging. This line should be resecured.

96. Unsecured Water Line

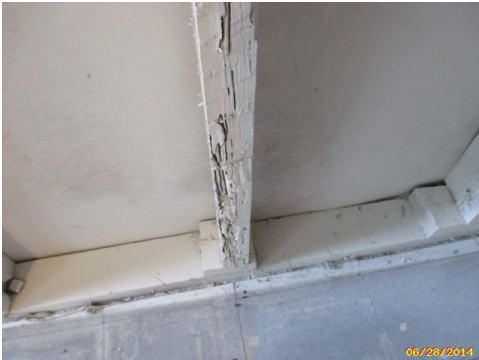
99. Sign Of Insect Damage

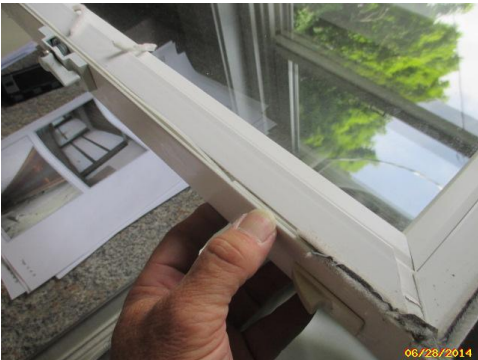
103. Damaged Weather Strip Windows

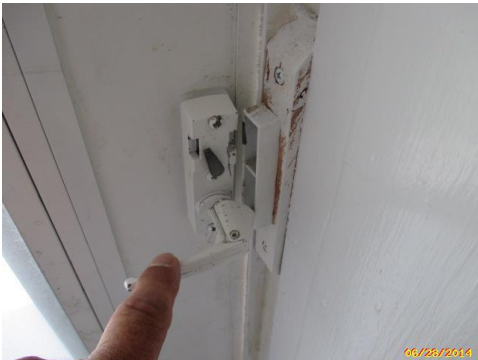
104. No Latch Storm Door
