Galloway Inspection Services, Inc.

Client: Cecil Galloway

Inspected On: 06-28-2014

Inspection Type: Personal Home Inspection

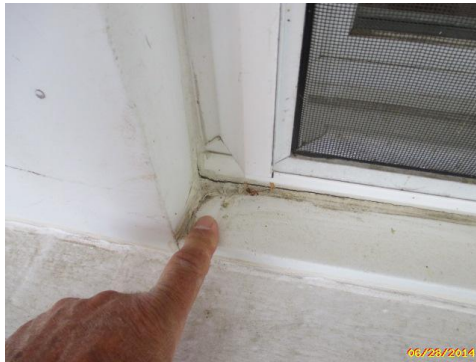
8. Gap At Window Trim

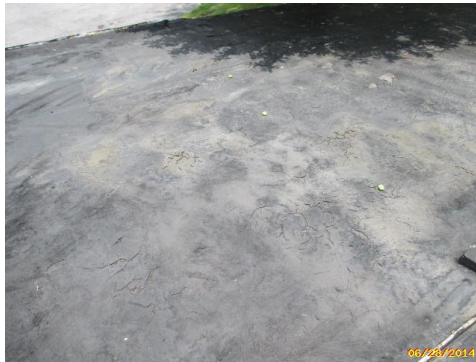
17. Sign Of Standing Water

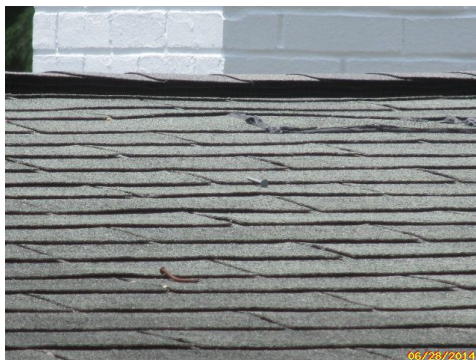
23. Old Repair

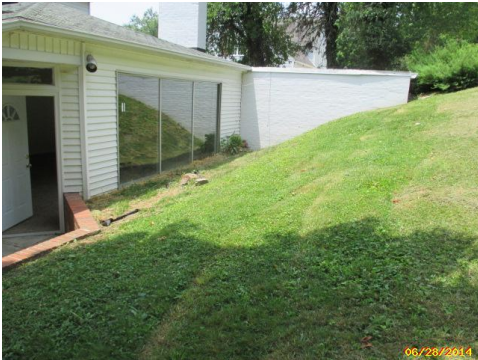
- There is a general slope from the rear of the lot to the front. The slope is rather steep and terminates at the rear of the garage and the house. There are no means present to divert any surface water that might run toward the house and contact the foundation. A control ditch or other structure should be installed to divert the water away from the foundation. A landscape contractor should be contacted to make recommendations for diverting the water flow.

26. Slope Toward House

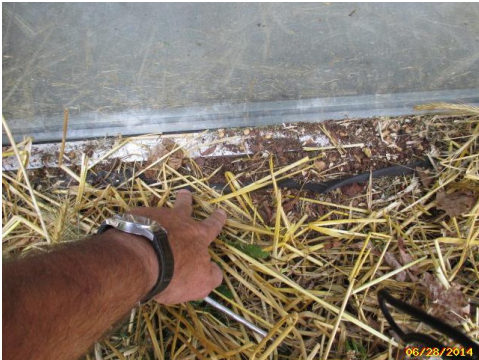
27. Ground At Window Height

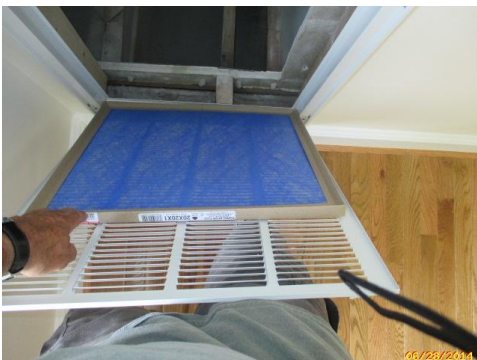
46. Main Floor Filter To Short

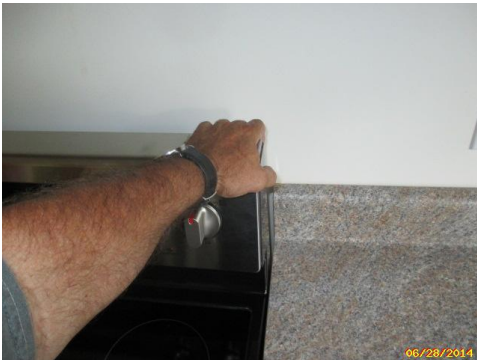
52. No Anti Tip Clip

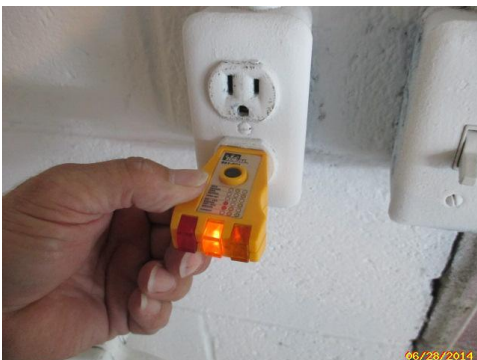
58. Ungrounded Receptacle Garage

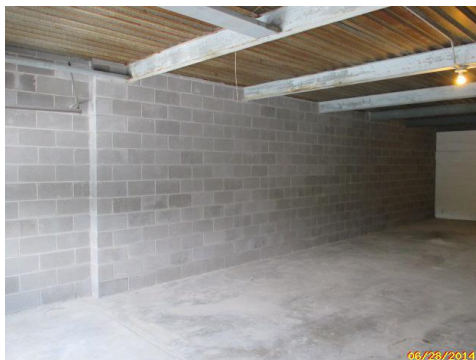
- The left exterior concrete block wall of the garage is collapsing. A new concrete concrete block wall and steel braces have been installed on the interior of this wall to prevent the original wall from failing. An engineering letter should be procured for the repairs made to the garage wall to ensure the repairs made will solve the issue. There is a settlement crack on the right side interior garage wall. The crack is small but should be sealed and monitored for any further widening. If the crack continues to widen, a licensed general contractor should be consulted to make recommendations for any needed repairs.

59. New Garage Wall

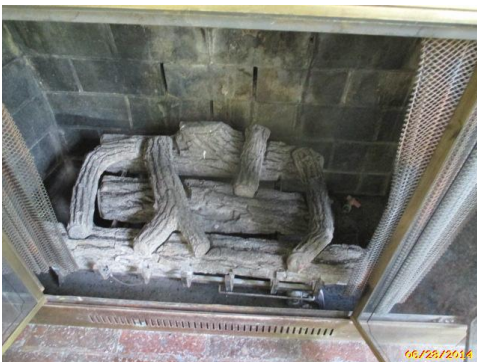
66. Gaps In Fire Brick

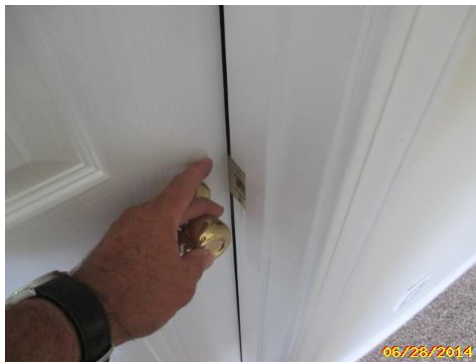
68. Laundry Door Not Close

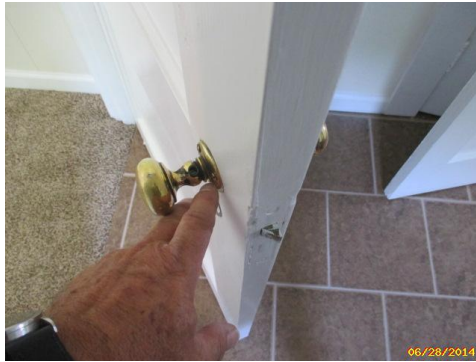
74. Bath Door Knob Not Working

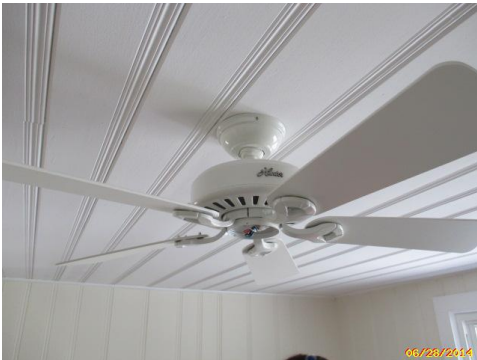
76. Ceiling Fan Not Working

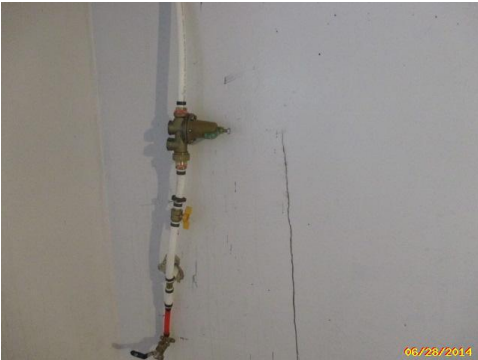
97. Main Water Shut Off

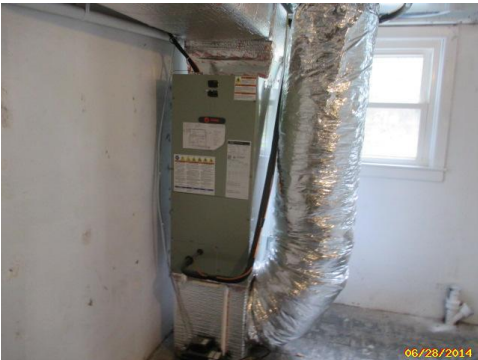
100. Air Handler

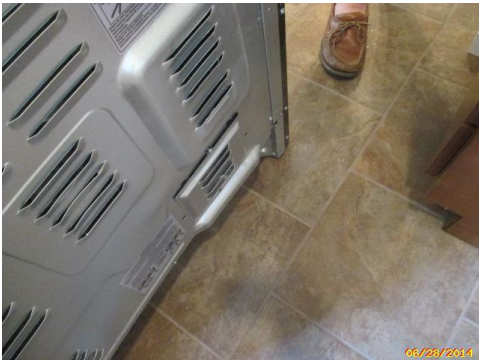
Checkpoint	Rating	Comment
Dishwasher:	S	
Range:	MR	The range is new but was not tested since there was not a cord and plug attached to the range. There is no anti tip clip for the range. The clip keeps the range from tipping forward if a load is placed on the door when opened. A clip should be installed for safety.
Oven:	S	
Microwave:	NA	
Range Hood:	NA	There is no range hood over the range. A vent hood should be installed exhaust any moisture from the house created by cooking.
Disposal:	S	
Trash Compactor:	NA	
Cook Top:	NA

102. No Cord On Range
